930,599 Mile Engine 1 Million Mile Van

Delivery Driver Tests AMSOIL

Measurements taken during analysis of 1999 Chevy Express 5.7 liter, 350 gasoline engine by an independent machinist in December 2007.

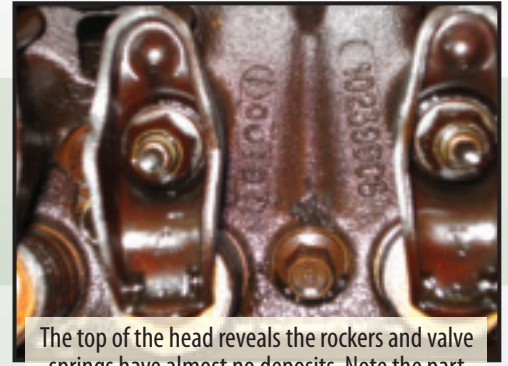
The top of the head reveals the rockers and valve springs have almost no deposits. Note the part numbers still are visible.

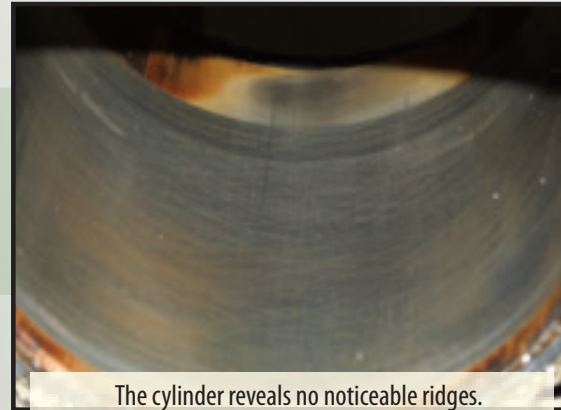
The cylinder reveals no noticeable ridges. Note crosshatch marks still are present.

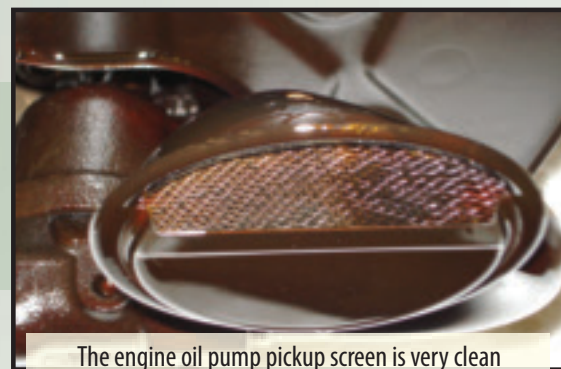
The engine oil pump pickup screen is very clean and has no deposits.

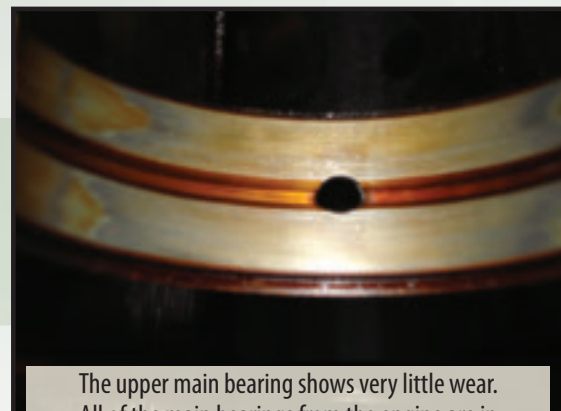
The upper main bearing shows very little wear. All of the main bearings from the engine are in useable condition, according to the analysis.
